Visual Pre Purchase Pest Inspection

Australian Standards AS 4349.3 -1998

97 Wild Street MAROUBRA.

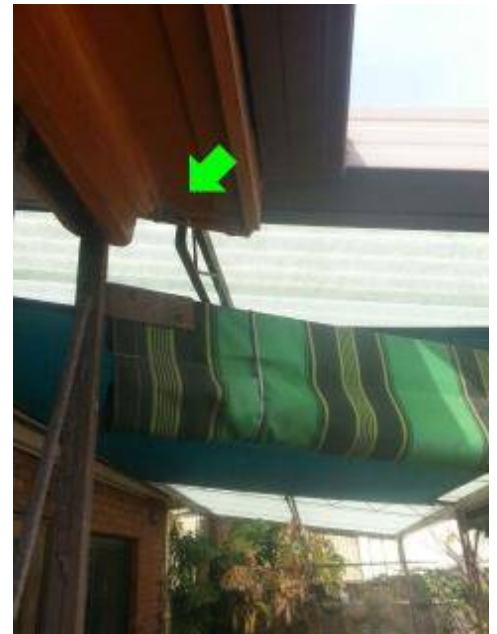
Rear section of the property.

Yes - Wood decay damage was noted to the following timbers/areas.

Fascia timbers: Fencing timbers:

Visible timber damage appears moderate. Please refer to the building report for details or if a building inspection was not commissioned we recommend a builder inspection and report on the property. Refer to the definitions section of this report - Section 1.6 - Timber Damage.

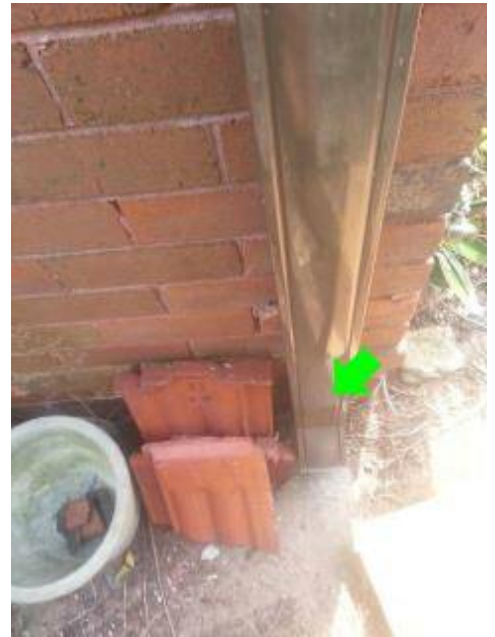
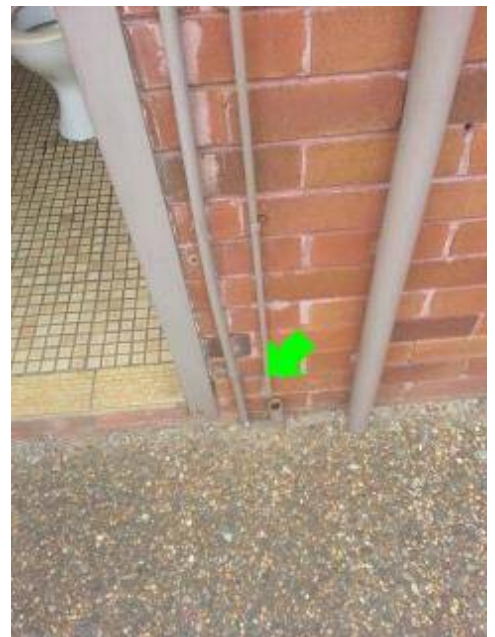
Some gutters and/or downpipes appear to discharge rainwater directly adjacent to the foundations of the structure. These should be connected to a stormwater dispersal system. The hot water system overflow is discharging moisture adjacent to the structure. We recommend the overflow be situated over a drain.

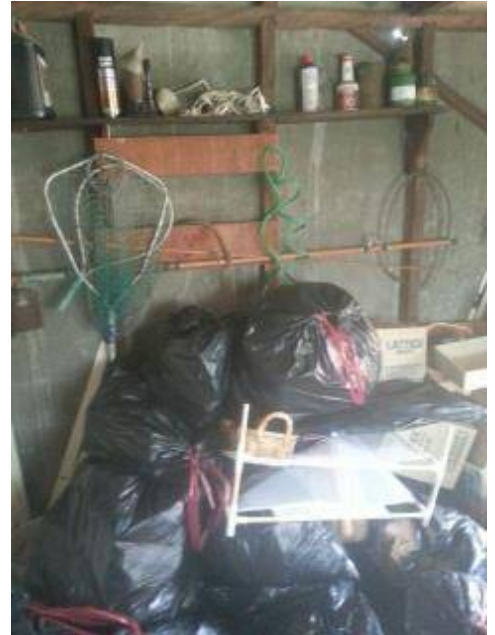
Stored items restricted inspection to the interior. These goods must be removed to enable a more complete report to be submitted.

Active termites or other timber damaging pests may be present and not detected in areas where inspection was limited, obstructed by stored goods or access was not gained. Recommend access be gained to this area.

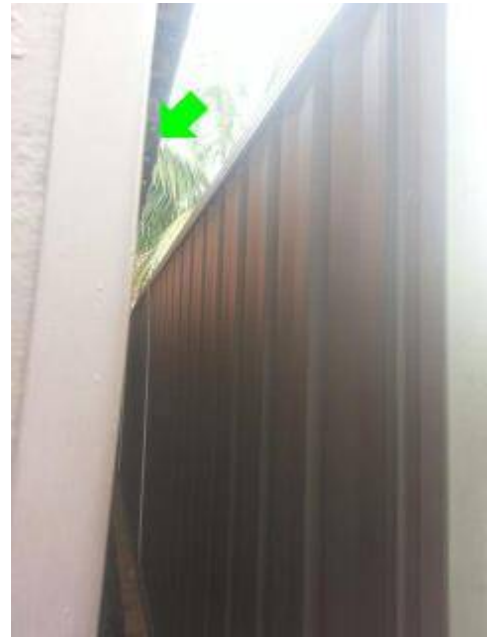
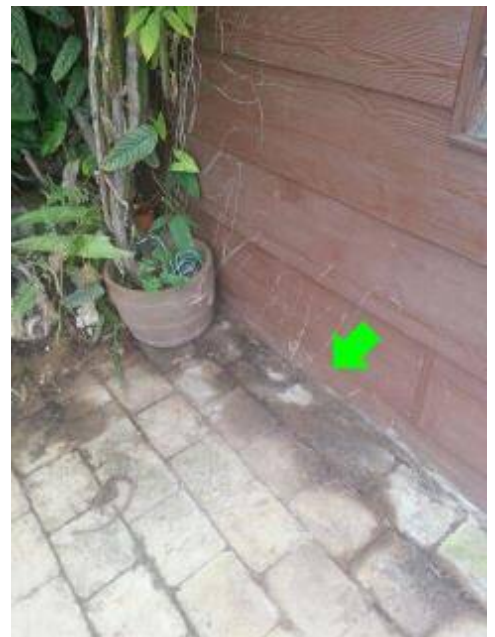
External cladding is in contact with soil. This can allow concealed termite entry and we recommend modifications be made so that soil is not in contact with cladding.

Water from the roof is discharging directly adjacent to the building. Excess water around the building should be connected to a stormwater dispersal system.

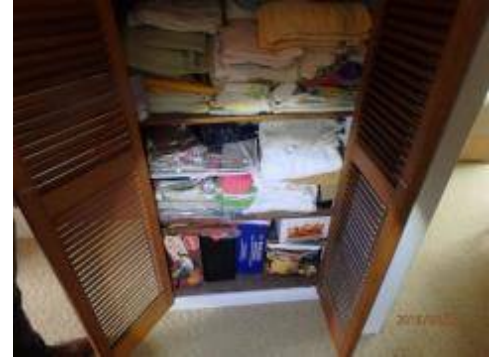
Both floorcoverings and furnishings were present and restricted inspection within this area. Inspection was limited in the following locations and or areas: Various areas.

A significant amount of stored goods were present to the area(s) listed below which restricted the inspection. Stored items should be removed to allow a more complete inspection to be carried out. Access was limited in the following locations and or areas: Various areas.

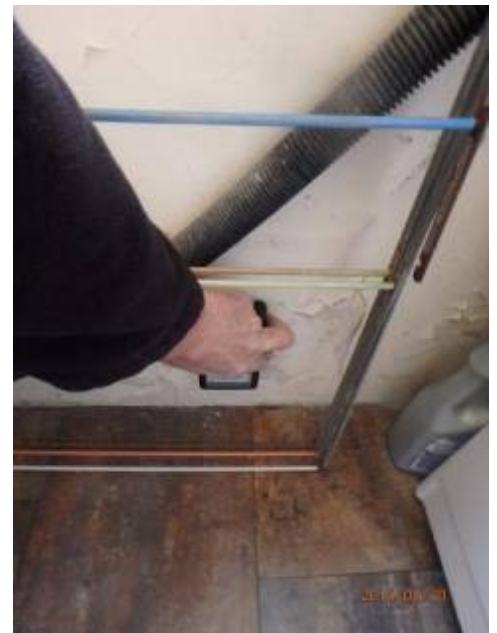
Laundry.

High moisture levels were detected to some internal walls as noted below. The moisture was considered higher than acceptable for the property inspected. This can be an indicator of a free moisture source (water leak) or possible timber pest activity. In all cases where a high moisture level is encountered, we strongly recommend further investigations be carried out to determine the cause of this situation.
